# FACILITY CONDITION ASSESSMENT

FACILITY CONDITION ASSESSMENT  
OF  
MARATHON/LAKE VIEW PROFESSIONAL PLAZA  
1200 LAKE VIEW DRIVE  
WAUSAU, WISCONSIN 54403

June 5, 2017

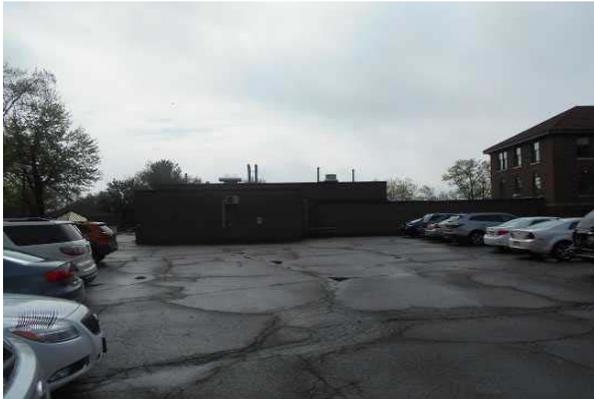
#7:	PARKING LOT
-----	-------------

- The asphalt pavement exhibits significant areas of failure and deterioration, such as alligator cracking, transverse cracking, extensive raveling, heavy overall surface wear, and localized depressions throughout the site. All of the paving must be overlaid with new asphalt paving in order to maintain the integrity of the overall pavement system. Milling is recommended as part of the overall repair work.
- The concrete curbs and gutters are in fair condition. Routine maintenance is required.

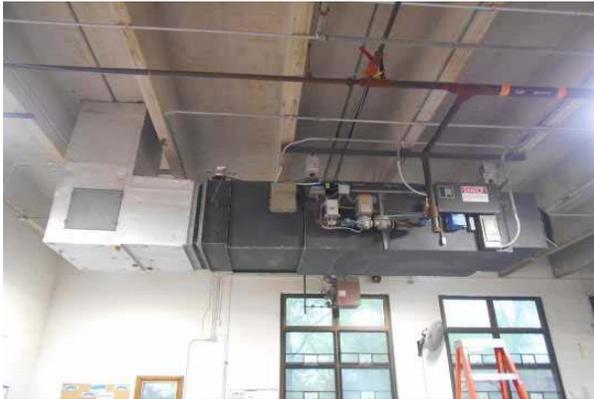
#25:	GAS FURNACE
------	-------------

- Mill and overlay of asphalt parking lots
- Upgrade Building Automation System (HVAC controls)
- Renovation of elevators
- Replacement of variable air volume unit
- Replacement of gas furnace

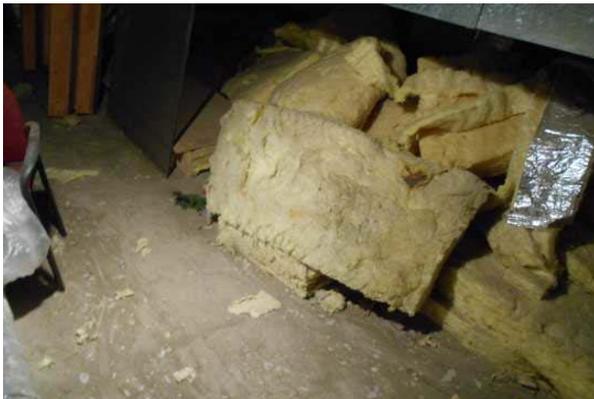
#27:	ATTIC INSULATION
------	------------------

- Repair moisture damaged interior plaster walls
- Missing ADA insulation on restroom sink drain pipes
- Installation of attic batt insulation
- Repair broken treads at site concrete stair
- Repair of collapsed underground sewer pipes
