UNIVERSITY OF WISCONSIN – MARATHON COUNTY

WAUSAU, WISCONSIN

## Residence Hall Consulting Study

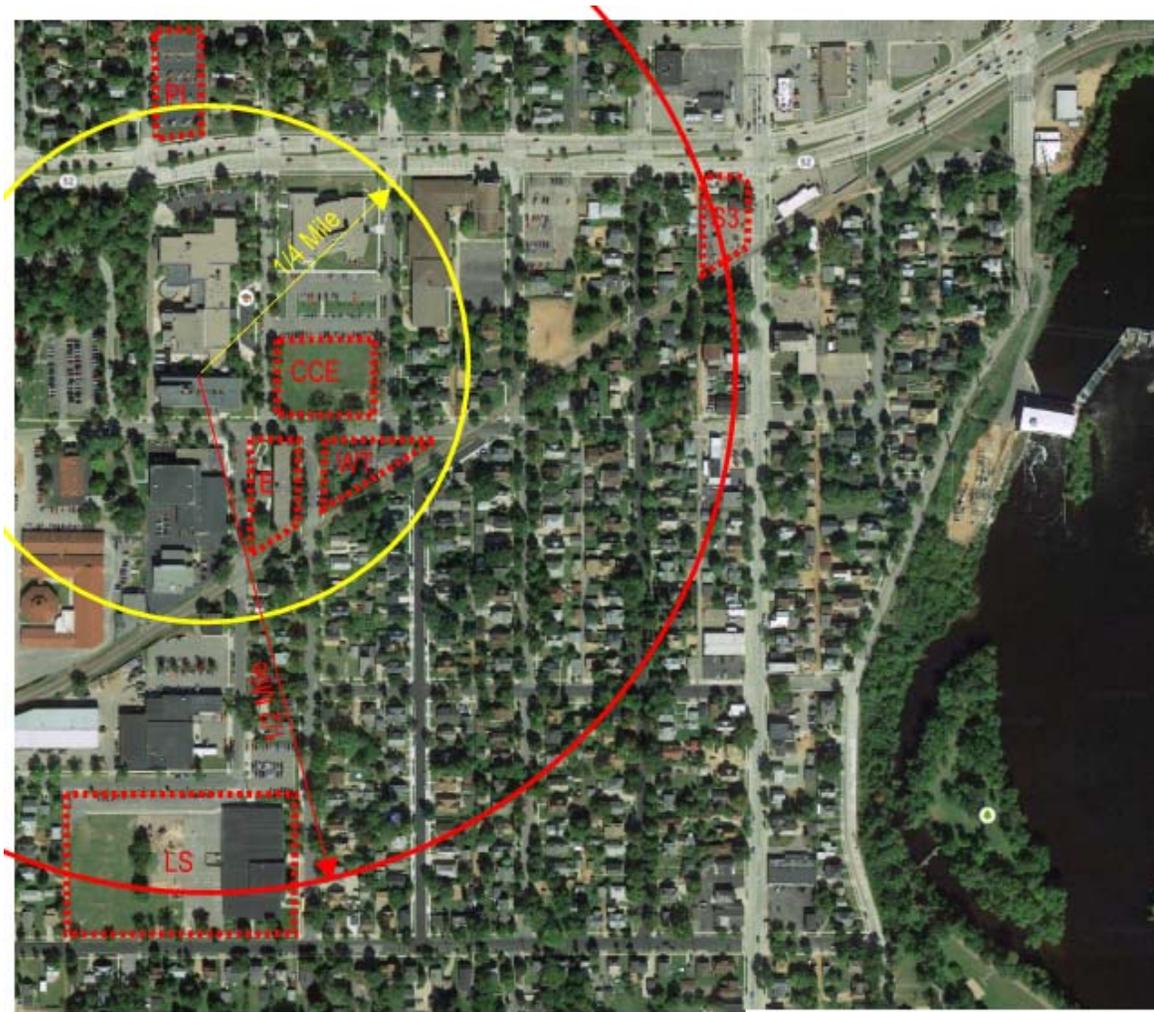
Large Context Site Plan

- CCE:** Site South of CCE
- PL:** Parking Lot Site
- WT:** Werle Triangle Site
- LS:** Lincoln School Site
- S3:** Stewart & 3rd Ave Site
- E:** Existing Residence Hall Site

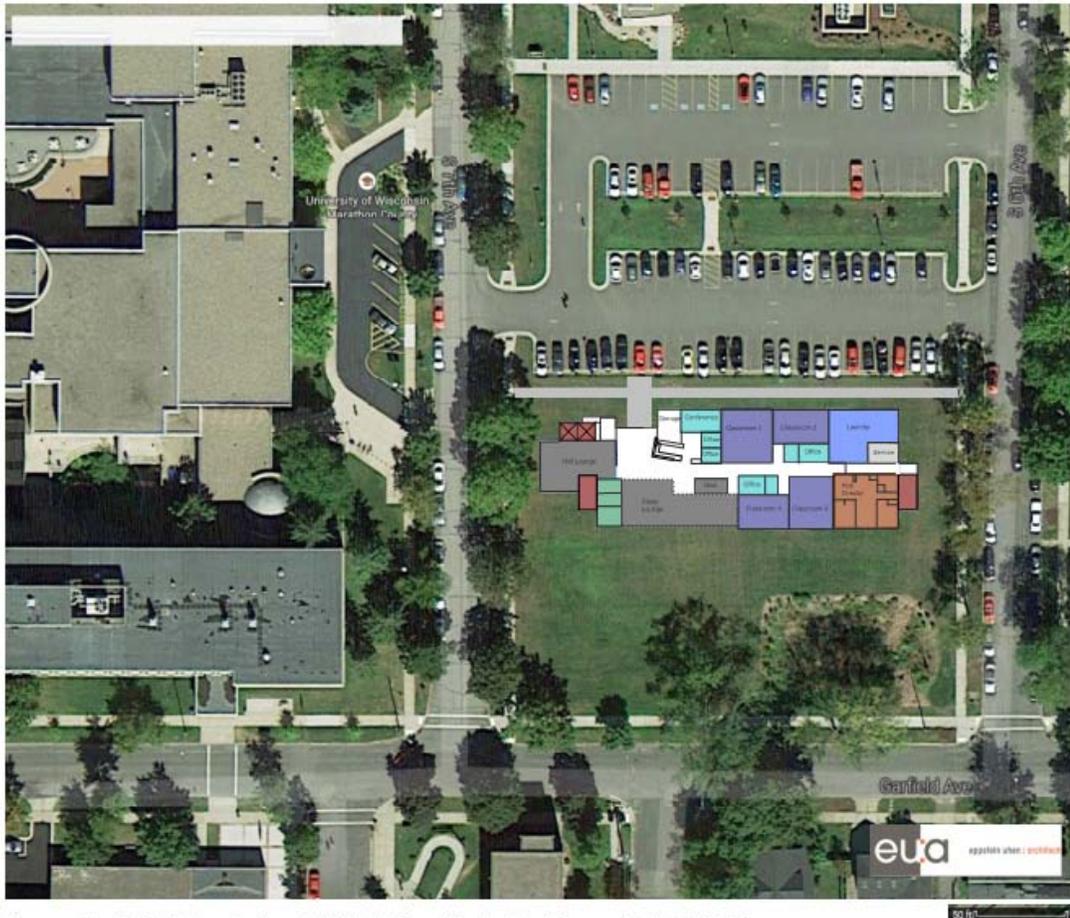
Conceptual Site Plan, 5 story 208 Bed Semi-Suite Residence Hall, CCE Site

Name of Site	South of CCE
Ranking	1
Proximity to Campus	On Campus
Correct Size to Accommodate Use?	Accommodates 5 Story Building, leaves room for double loaded parking or another building
Topography	Relatively Flat
Utilities	City Utilities
Easements	
Zoning	UDD Unified Development District
Setbacks	Defined by UDD Agreement
Ownership Status	Owned by County
2013 Assessed Land Value	n/a
Parking	Room for Double Loaded Parking
Demolition/Remediation	No Demolition Needed
Suitability for Other Uses	Prime Site for other future Campus Buildings
Other Challenges	The Campus Master Plan targets this site for future Academic Buildings. This site has an existing storm water management basin that needs to be accounted for in any site development

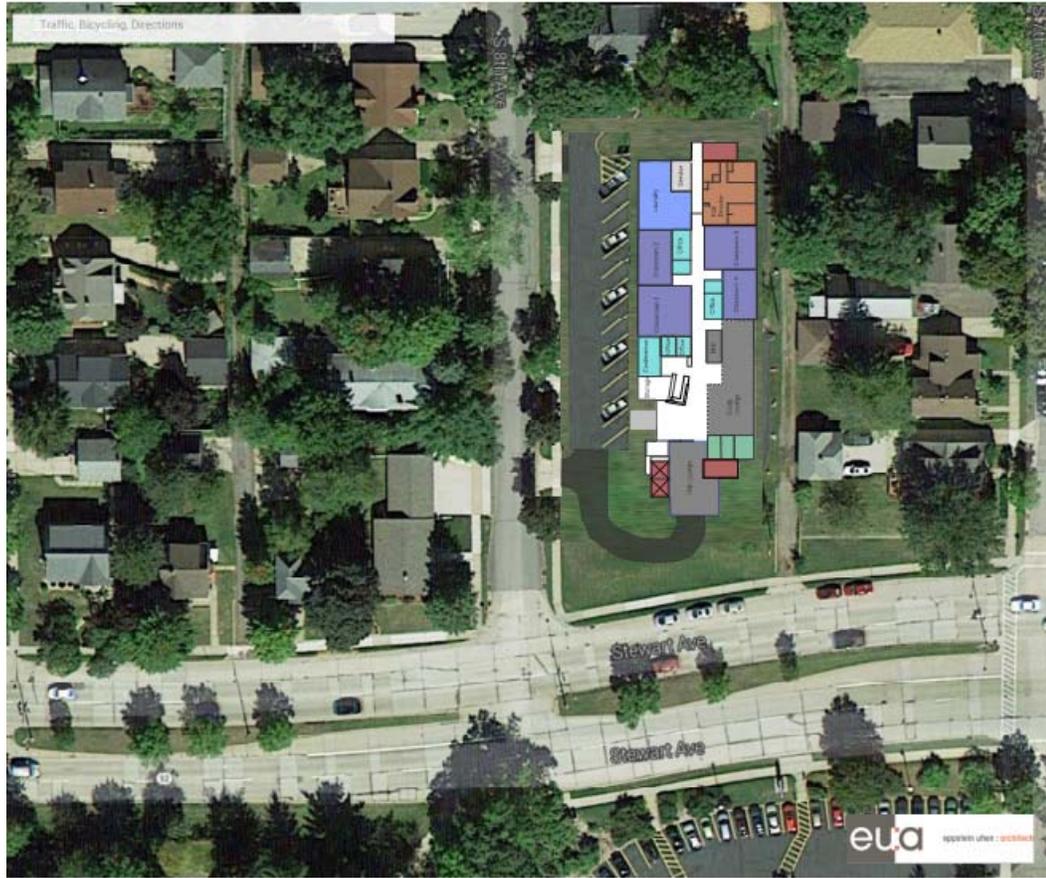
Conceptual Site Plan, 5 story 208 Bed Semi-Suite Residence Hall, Parking Lot Site

Name of Site	Parking Lot
Ranking	2
Proximity to Campus	Adjacent to Campus, North of Stewart Ave
Correct Size to Accommodate Use?	Accommodates 5 Story Building and single loaded parking lot
Topography	Steep slope North to South, could accommodate walk out basement or basement parking access
Utilities	City Utilities
Easements	
Zoning	R3, 2 Family Residential
Setbacks	Front, 20'; Rear, 30'; Side 8'
Ownership Status	Owned by County
2013 Assessed Land Value	n/a
Parking	Room for Single Loaded Parking
Demolition/Remediation	Parking Lot Demolition Required
Suitability for Other Uses	Secondary site for other future Campus Buildings
Other Challenges	Stewart Avenue is dangerous for pedestrians to cross due to very heavy traffic. The City, County, and State are resistant to adding a Traffic Light

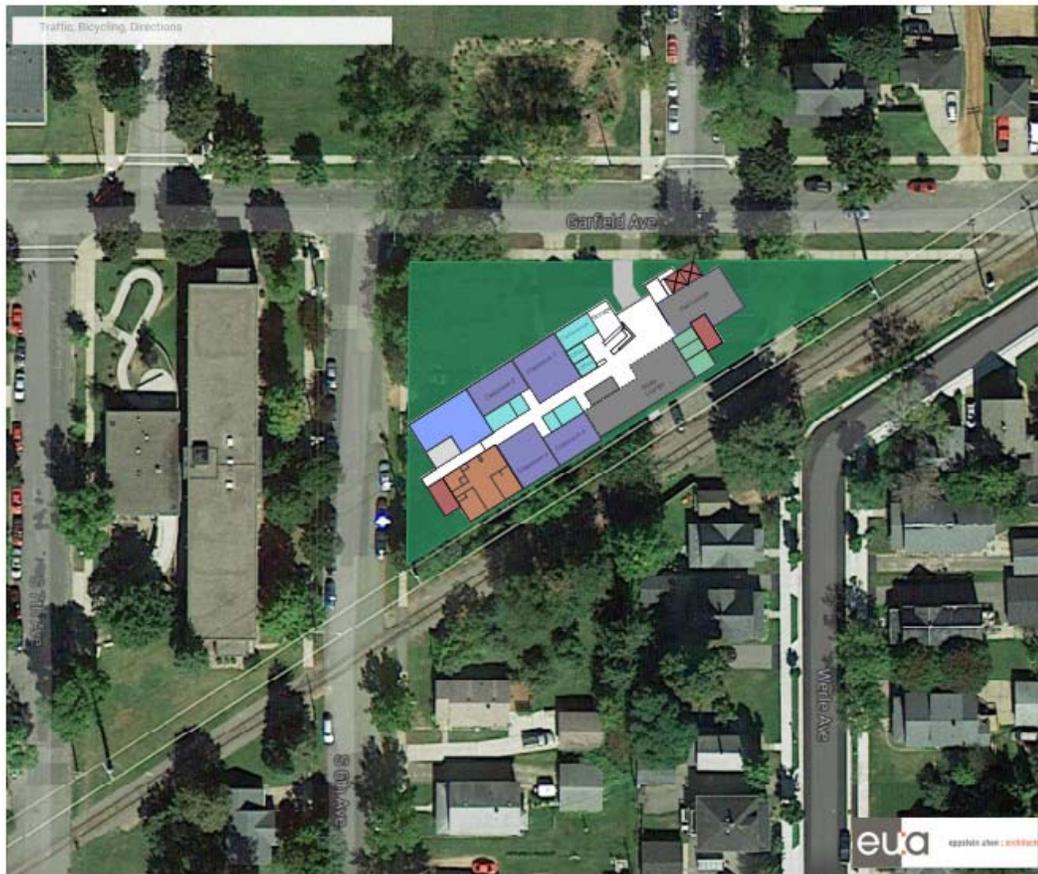
Conceptual Site Plan, 5 story 208 Bed Semi-Suite Residence Hall, Werle Triangle Site

Name of Site	Werle Triangle
Ranking	3
Proximity to Campus	Adjacent to Campus, South of Garfield Ave
Correct Size to Accommodate Use?	Accommodates 5 Story Building with no Setbacks, no Parking
Topography	Relatively Flat
Utilities	City Utilities
Easements	High voltage power lines along south lot line
Zoning	R3, 2 Family Residential; R2, Single Family Residential
Setbacks	Front, 20'; Rear, 30'; Side 8'
Ownership Status	Three Separate Private Owners
2013 Assessed Land Value	\$309,500
Parking	No Room for Parking
Demolition/Remediation	Demolition of houses, basements, likely some remediation
Suitability for Other Uses	Secondary site for other future Campus Buildings
Other Challenges	The size and shape of this site coupled with the high voltage power line easement to the south make the buildable area of the site very small

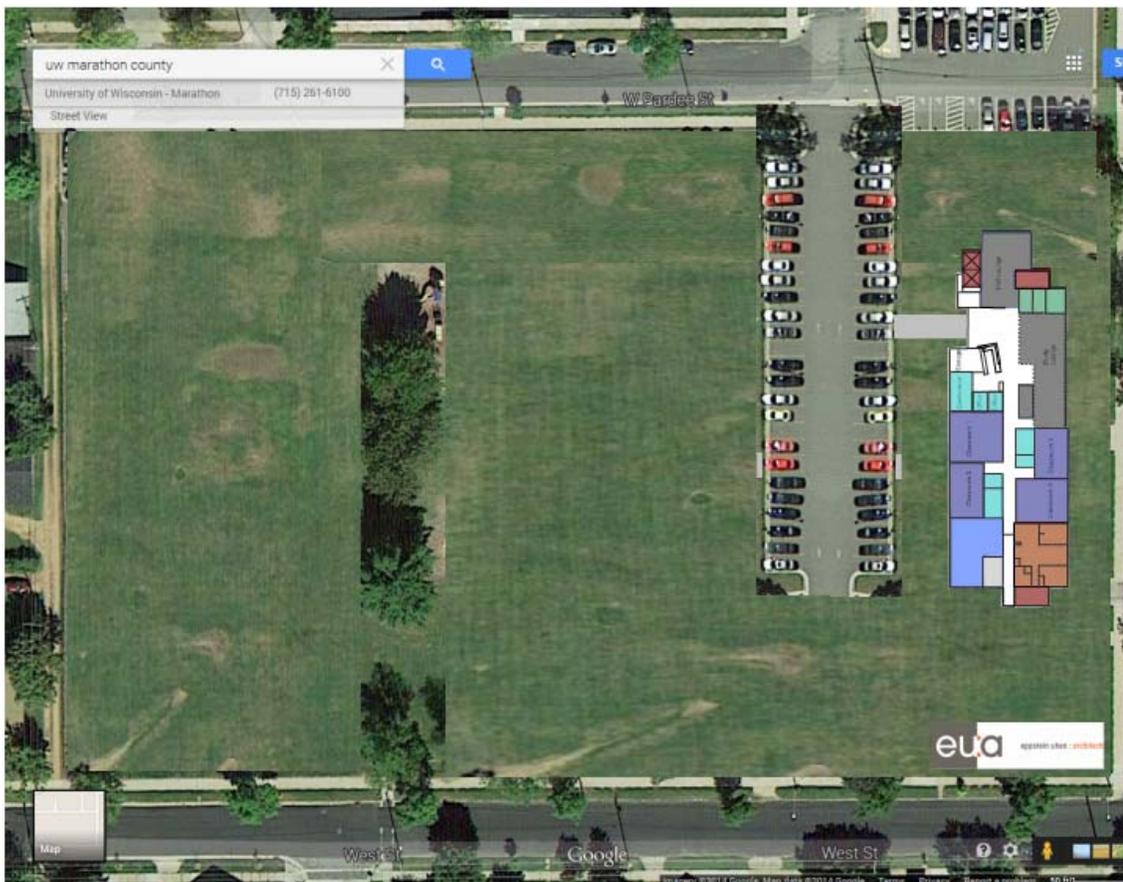
Conceptual Site Plan, 5 story 208 Bed Semi-Suite Residence Hall, Lincoln School Site

Name of Site	Lincoln School
Ranking	4
Proximity to Campus	1/3 Mile South of Campus
Correct Size to Accommodate Use?	Accommodates 5 Story Building, double loaded parking, and leaves 3/4's of the site for other uses
Topography	Relatively Flat
Utilities	City Utilities
Easements	
Zoning	R3, 2 Family Residential
Setbacks	Front, 20'; Rear, 30'; Side 8'
Ownership Status	Owned by City
2013 Assessed Land Value	not available
Parking	Room for Double Loaded Parking
Demolition/Remediation	Demolition of School, likely some remediation
Suitability for Other Uses	Large site, not adjacent to Campus, poor suitability for other Campus uses due to distance from Campus
Other Challenges	There is no campus need identified in the Master Plan for the site area leftover after accommodating the residence hall and parking

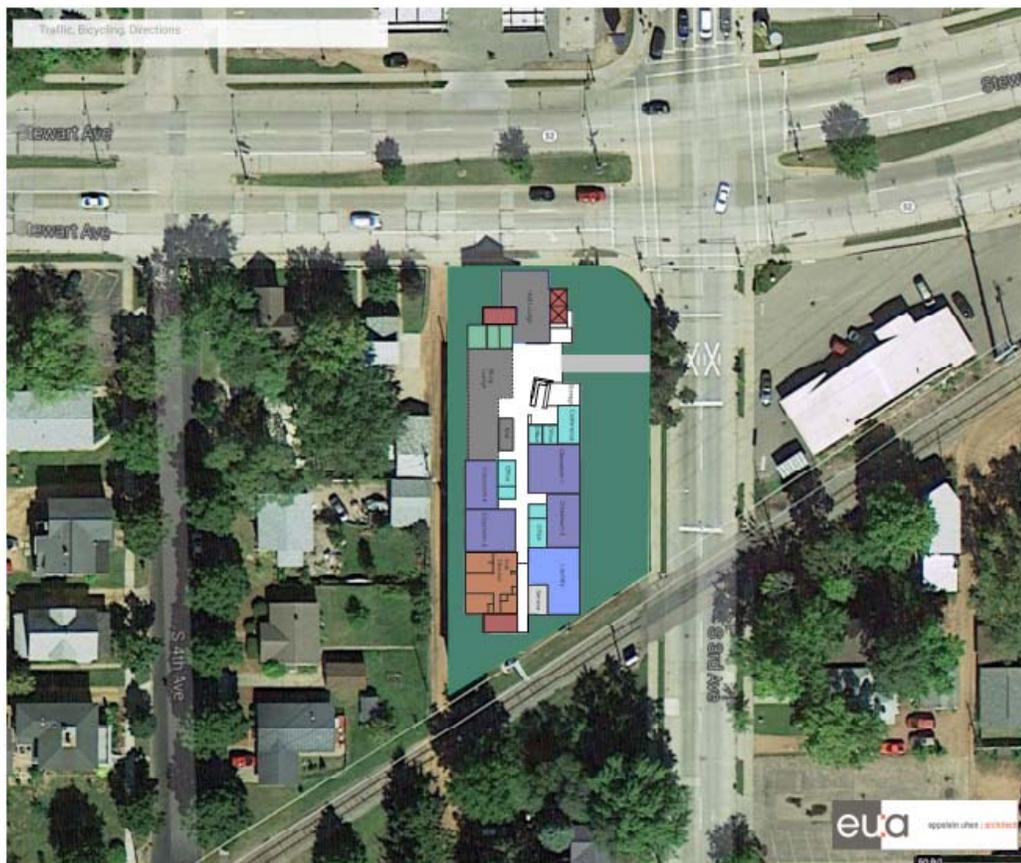
Conceptual Site Plan. 5 story 208 Bed Semi-Suite Residence Hall. Stewart Ave and 3rd Street Site

Name of Site	Stewart & 3rd Ave
Ranking	5
Proximity to Campus	1/2 Mile East of Campus
Correct Size to Accommodate Use?	Accommodates 5 Story Building with small Setbacks, no Parking
Topography	Relatively Flat
Utilities	City Utilities
Easements	
Zoning	B2, Community Service
Setbacks	Front, 15'; Rear, 30'; Side 5'
Ownership Status	Two Separate Private Owners
2013 Assessed Land Value	\$376,700
Parking	No Room for Parking
Demolition/Remediation	Demolition of Building and Parking, likely some remediation
Suitability for Other Uses	Small site, not adjacent to Campus, poor Suitability for other Campus uses due to distance from Campus. Good candidate for revitalizing private mixed use development
Other Challenges	Students are very concerned about personal safety at this site

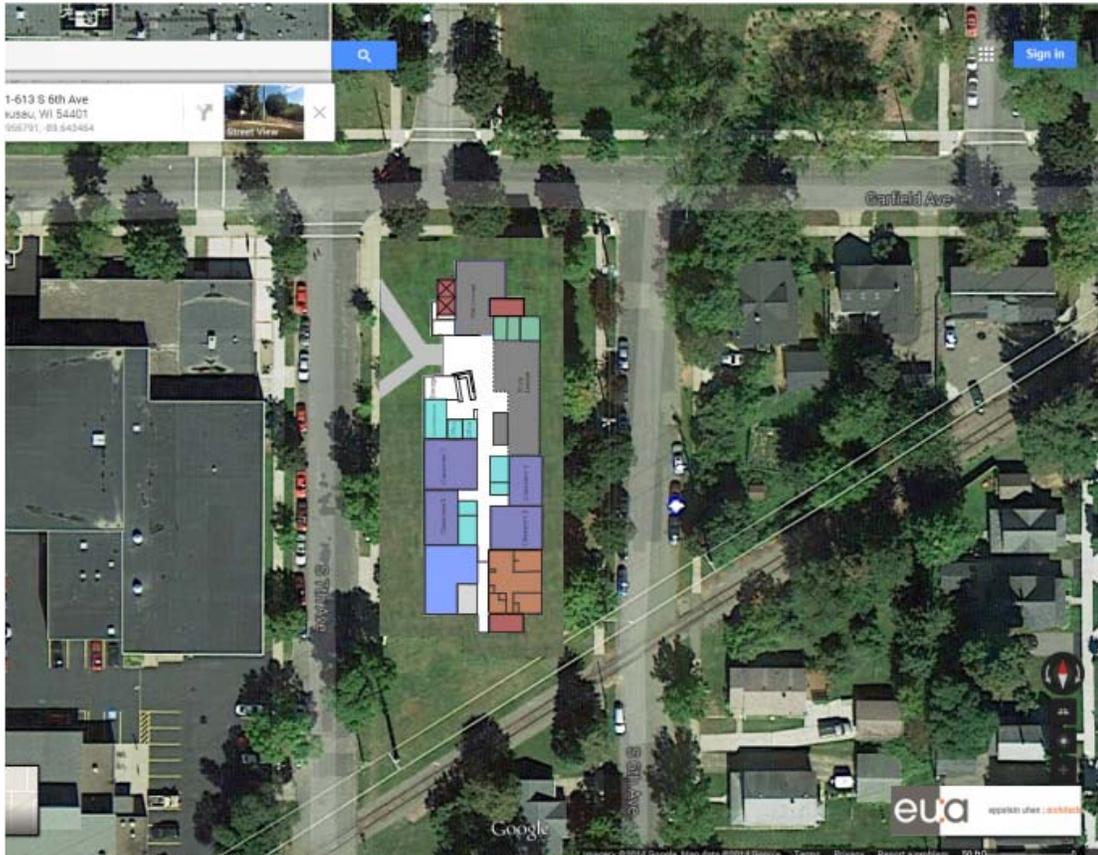
Conceptual Site Plan, 5 story 208 Bed Semi-Suite Residence Hall, Existing Marathon Hall Site

Name of Site	Existing Marathon Hall
Ranking	6
Proximity to Campus	On Campus
Correct Size to Accommodate Use?	Accommodates 5 Story Building, no Parking
Topography	Relatively Flat
Utilities	City Utilities, Campus Steam
Easements	High voltage power lines along south lot line
Zoning	R2, Single Family Residential
Setbacks	Front, 20'; Rear, 30'; Side 8'
Ownership Status	Owned by County
2013 Assessed Land Value	n/a
Parking	No Room for Parking
Demolition/Remediation	Demolition of Building, some remediation
Suitability for Other Uses	The existing Residence Hall superstructure and floor to floor heights do not efficiently accommodate uses other than Housing
Other Challenges	Building on this site would require taking the existing student housing off-line for two summers and one academic year, which would have a very detrimental effect on the housing program

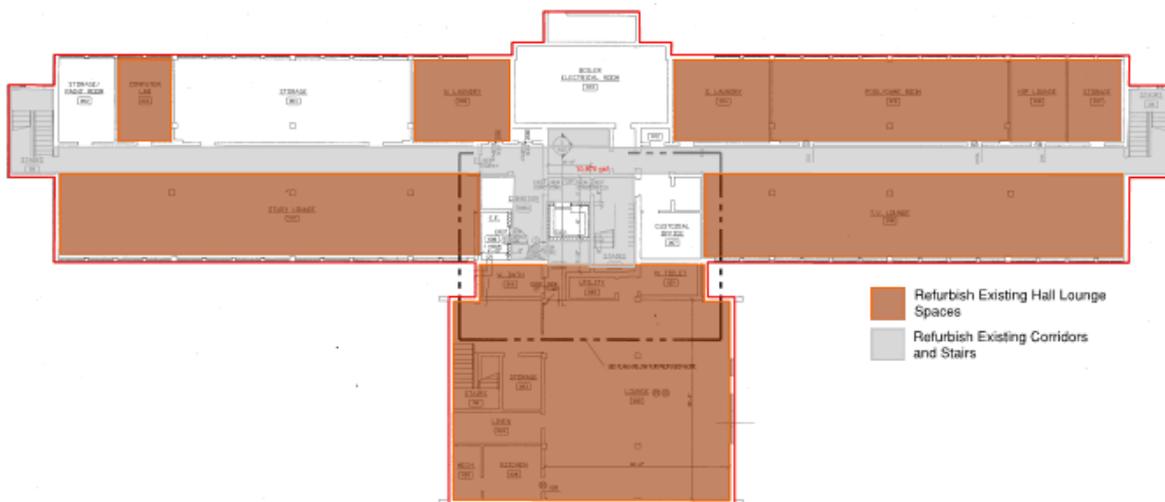
Ground Floor Plan, Refurbish

<b>scope of work</b>	Replace roofing. Tuckpoint and re-caulk exterior. Replace remaining original windows and doors. Replace all interior finishes. Skim coat plaster all concrete block walls in corridors and public areas. Gut and replace existing bathrooms in their current locations and current number of fixtures. Reconfigure lower level lounge area and kitchen to function better. Replace all existing MEP systems, add A/C.
<b>representative photo of construction type</b>

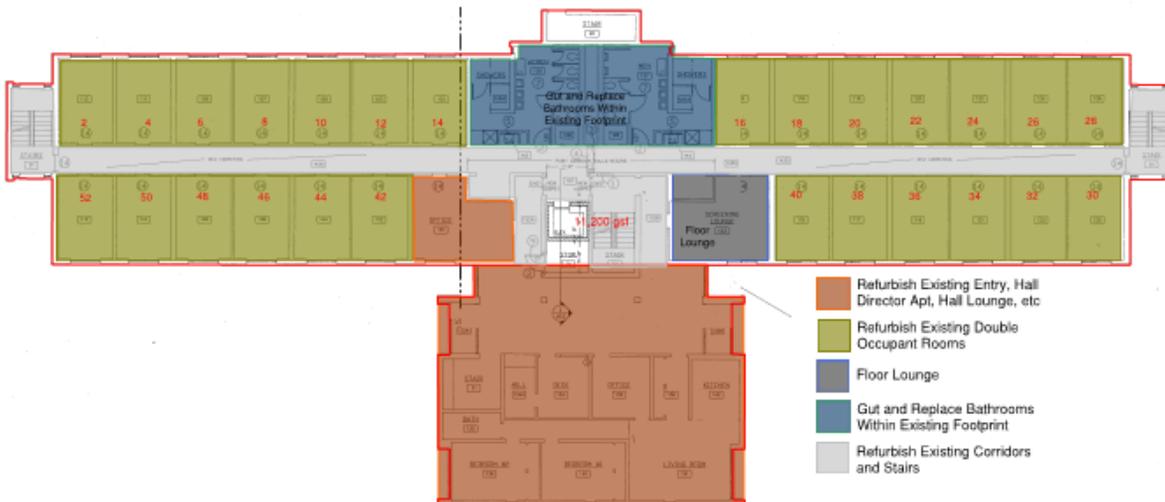
First Floor Plan, Refurbish

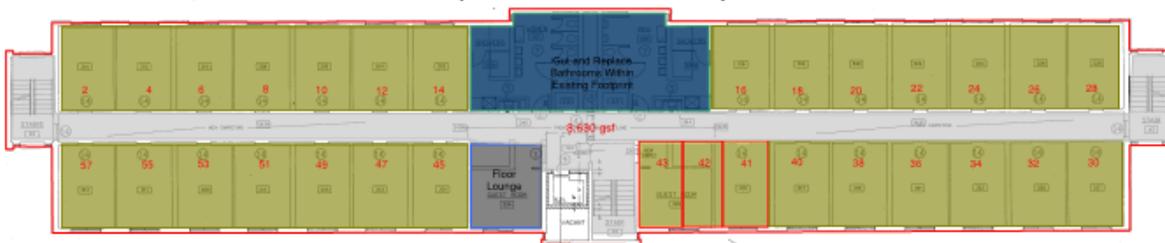
Second and Third Floor Plans, Refurbish

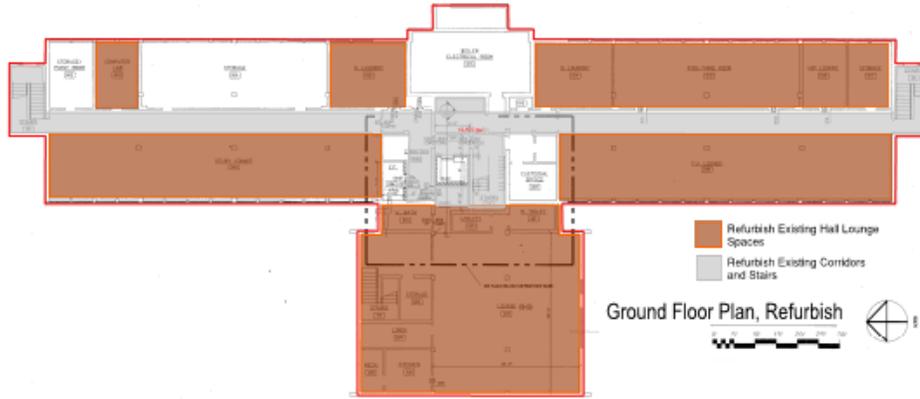
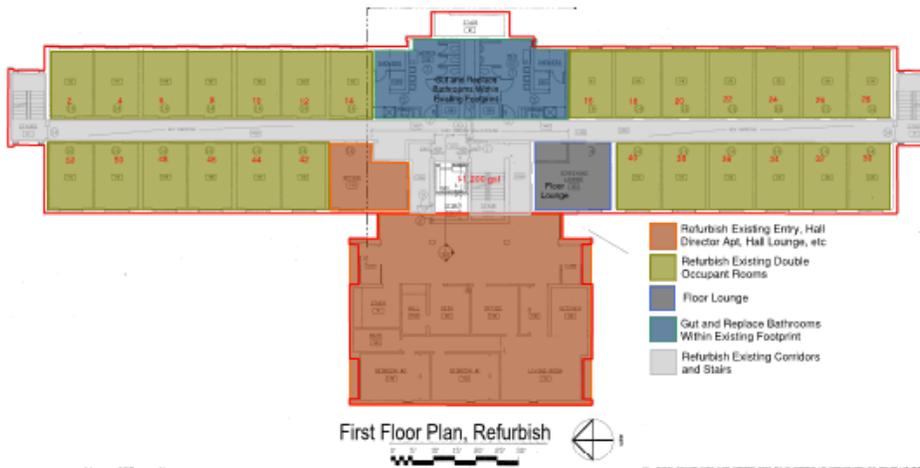
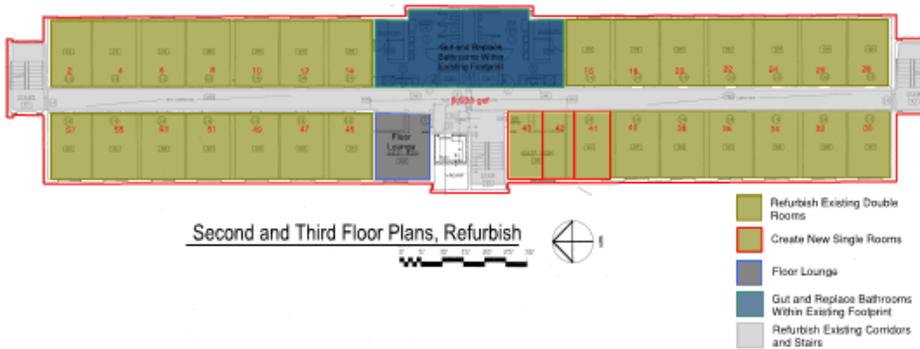
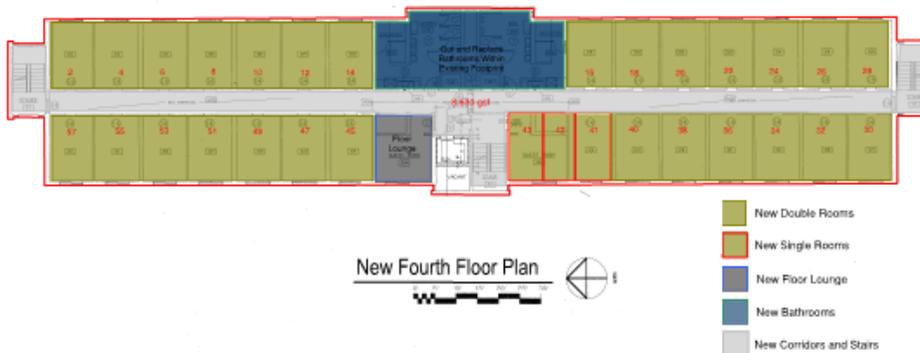
<b>scope of work</b>	Add a Fourth Floor*. Replace elevator with a unit that can travel to a 4th floor. Tuckpoint and re-caulk exterior. Replace remaining original windows and doors. Replace all interior finishes. Skim coat plaster all concrete block walls in corridors and public areas. Gut and replace existing bathrooms in their current locations and current number of fixtures. Reconfigure lower level lounge area and kitchen to function better. Replace all existing MEP systems, add A/C. *Adding a new Fourth Floor has been shown as a potential Option as part of this Study. Before this Option is selected more detailed study needs to be done on the capacity of the existing building structure and soils.
<b>representative photo of construction type</b>

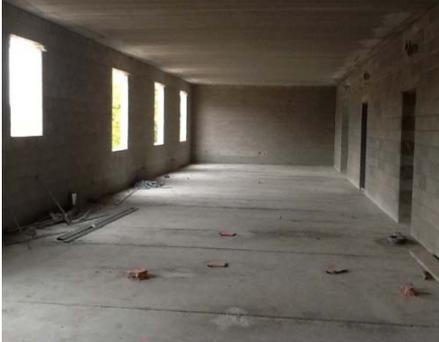
<b>New Semi-Suite Hall scope of work Option 2</b>	Construct a new 210 bed semi-suite style residence hall. <b>Construction systems shall be institutional quality, with a 50 year lifespan.</b> Superstructure to be <b>precast concrete plank supported by concrete block bearing walls.</b> Floor to floor heights to be 12'-8" at basement and 1st floor, and 10'-8" at residential floors 2, 3, 4, and 5. Exterior to be brick and stone cavity wall with CMU backup. MEP systems to be institutional quality. Building to have A/C
representative photo of construction type

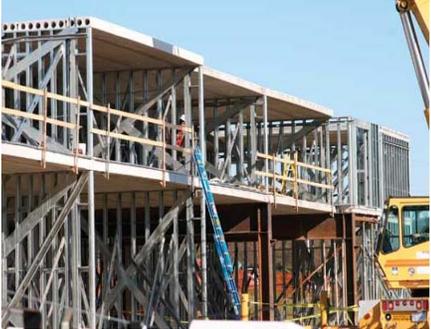
<b>New Semi-Suite Hall scope of work Option 3</b>	Construct a new 210 bed semi-suite style residence hall. <b>Construction systems shall be heavy commercial, with a 30 year lifespan.</b> Superstructure to be <b>steel frame with 30' x 30' bay spacing, steel joists, and concrete floors.</b> Floor to floor heights to be 12'-8" at basement, 13'-8" at 1st floor, and 10'-8" at residential floors 2, 3, 4, and 5. Exterior to be brick and stone cavity wall with metal stud backup. MEP systems to be commercial quality. Building to have A/C
representative photo of construction type

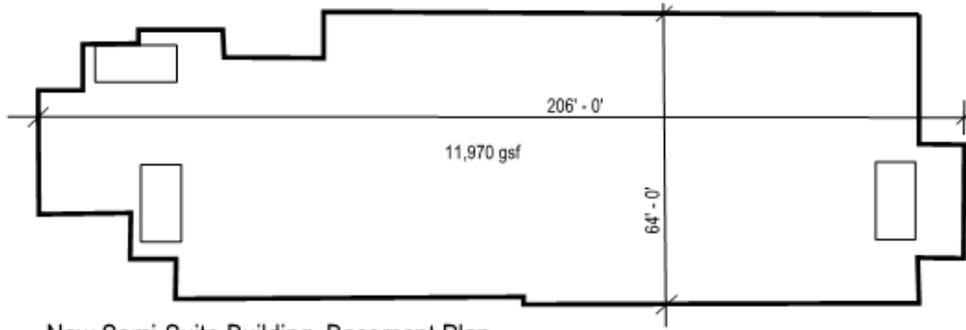
New Semi-Suite Building, Basement Plan

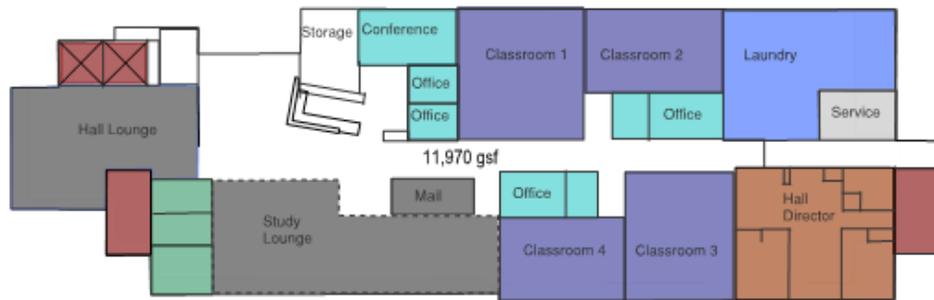
New Semi-Suite Building, First Floor Plan

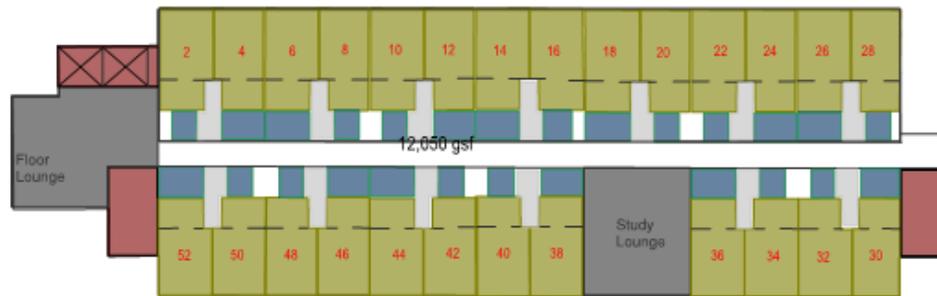
New Semi-Suite Building, Second, Third, Fourth and Fifth Floor Plans, 208 Beds

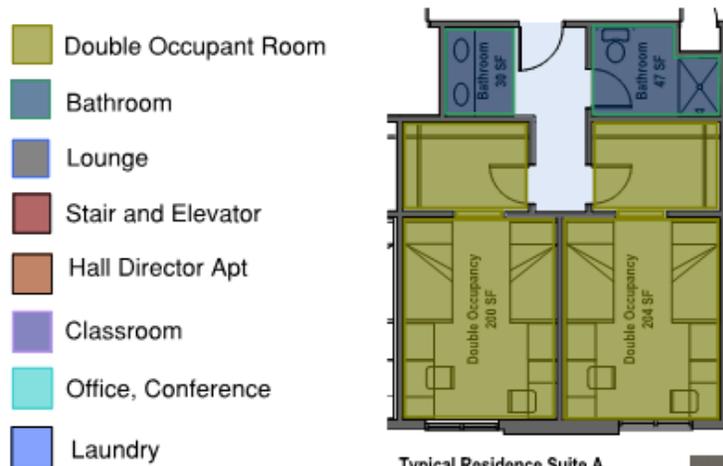
Typical Residence Suite A
